ULTRASONIC PLY-BY-PLY DETECTION OF MATRIX CRACKS IN
LAMINATED COMPOSITES

A Thesis

Major Subject: Aerospace Engineering

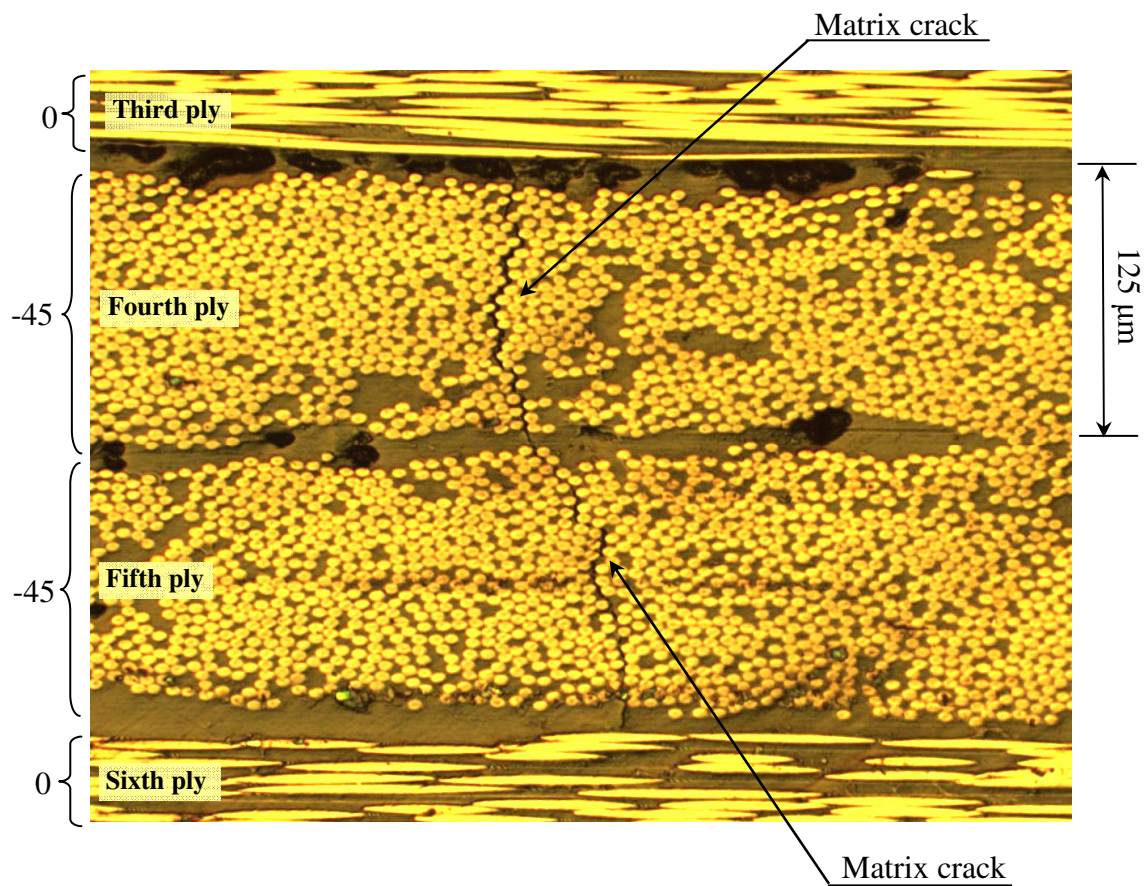
Fig. 1.1 Optical micrograph showing matrix cracks in the fourth and the fifth ply of an eight-ply $[90/45/0/-45]_s$ graphite/epoxy laminate.

A photograph of a part of the edge of an eight-ply $[90/45/0/-45]_s$ graphite/epoxy composite laminate is shown in Fig. 1.1; a matrix crack is clearly visible. A build up of matrix cracks in all plies of a laminated composite wall of a tank may lead to the formation of a network of interconnected cracks through the thickness of the tank-wall and provide a path for fuel to permeate to the outside [3-7]. The ignition energy of hydrogen in air is extremely low; 0.02 mJ [8]. A concentration of 4% (or more) of hydrogen in air is flammable [8,9]. Therefore the leakage of hydrogen to atmosphere may lead to extremely dangerous situations. In order to ensure the safety of the RLVs, it is critical to accurately predict the fuel leakage from the tank to the outside in order to ensure that it does not leak above a certain acceptable limit even after several launches of the space vehicle. Some elementary models have been developed to predict the permeability of a cryogenic propellant through the matrix cracks in a damaged composite laminate; see, for example, Aoki et al. [4], McManus et al. [6] and Kumazawa et al. [7]. These models require an a priori knowledge of the matrix cracks in all the plies and the interconnectivity between them.

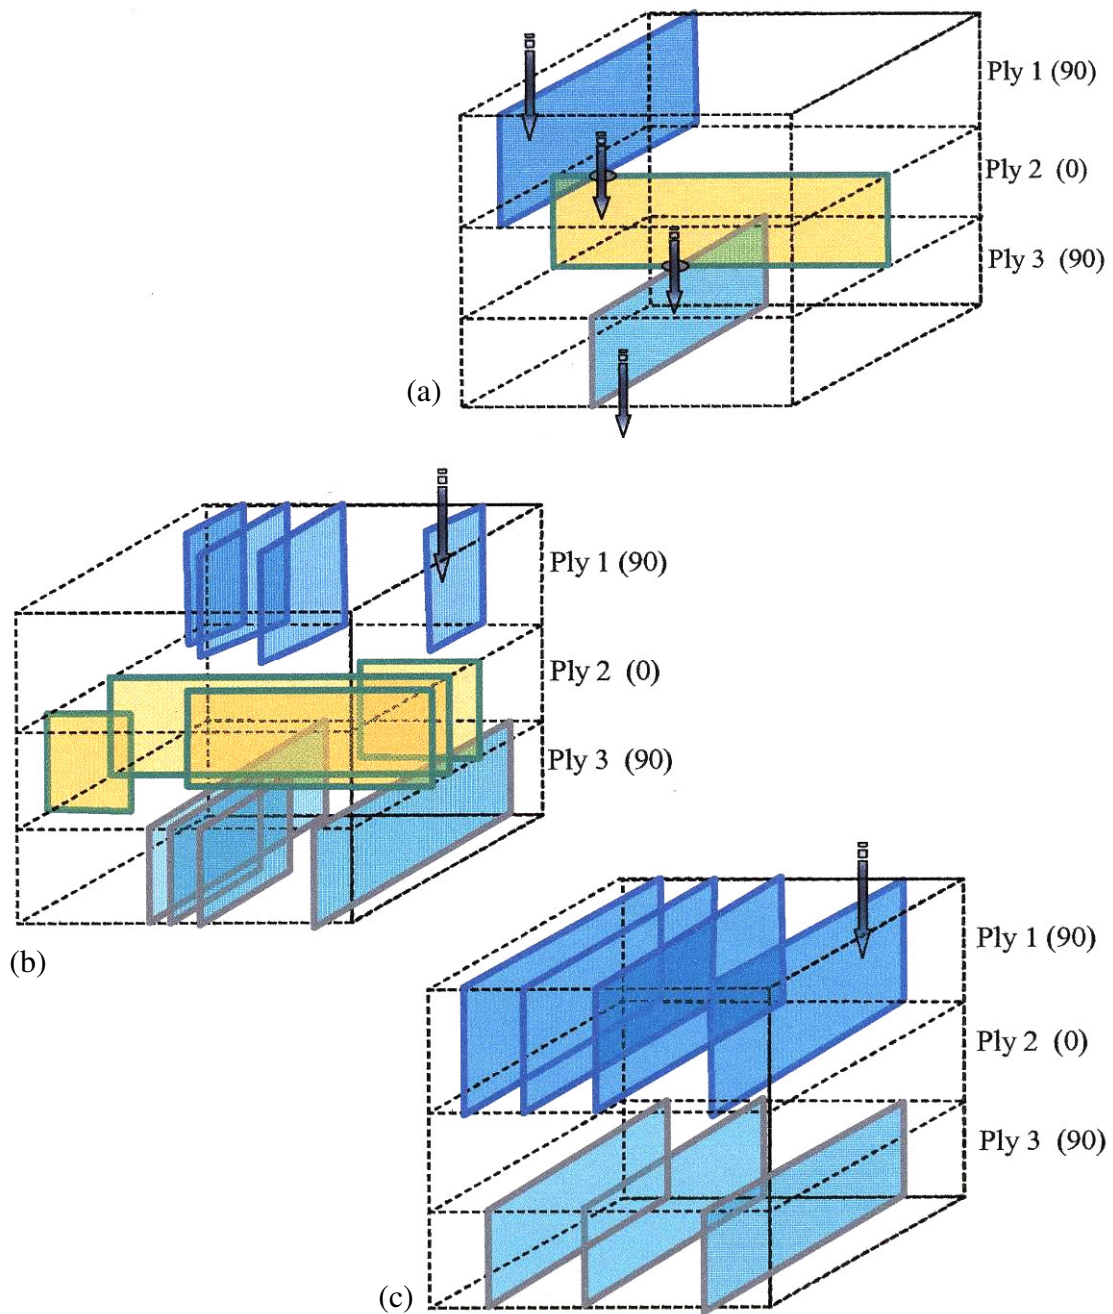
Fig. 1.2 A schematic of the possible arrangements of matrix cracks in a damaged [90/0/90] laminate. (a) Interconnected cracks; leakage occurs (b) no cracks in the second ply; leakage does not occur (c) cracks in the first ply do not intersect cracks in the second ply; leakage does not occur.

The presence of matrix cracks is *a necessary but not a sufficient* condition for leakage to occur through the thickness of a laminate. This is explained with the help of Fig. 1.2. As an illustrative example, consider a three-ply $[90/0/90]$ laminate with just one crack in each ply. The cracks are arranged in such a way as to allow a continuous path for flow of the propellant from the upper side of the laminate to the lower side, as shown schematically in Fig. 1.2(a). Now, consider a situation in which two of the plies contain a large number of matrix cracks, but one ply (the middle ply) is undamaged as

represented in Fig. 1.2(b). Evidently, there will be no leakage through the laminate thickness in this case. Finally, consider a situation where all three plies contain matrix cracks but there is not even a single intersection between the cracks in the first ply and those in the second ply; this is illustrated in Fig. 1.2(c). Once again, there will be no leakage across the laminate. Evidently, in addition to the density of the cracks, the extent and the spatial arrangement of the cracks in each ply is also required for the prediction of permeability. This defines the objective of this thesis: the development of an ultrasonic *ply-by-ply* NDE technique for the detection of matrix cracks in laminated composites.

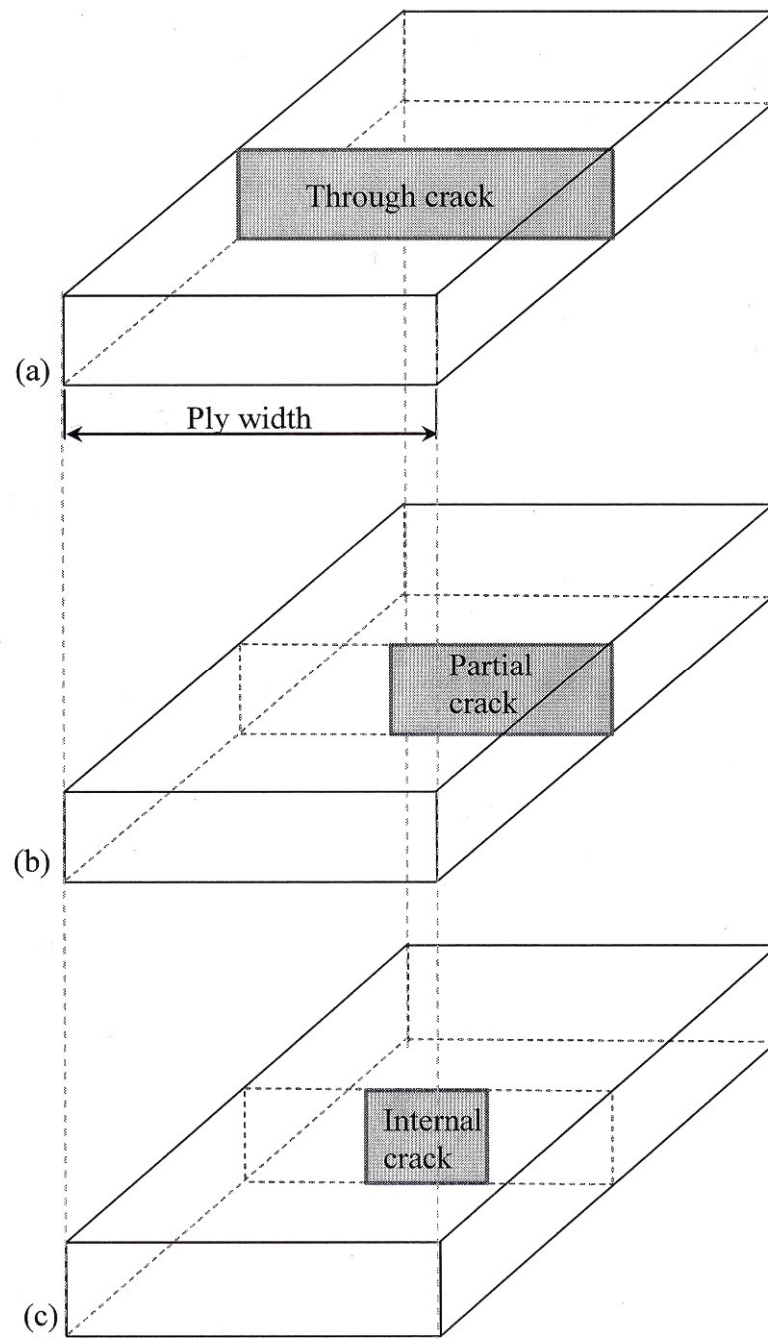
Fig. 1.3 A schematic illustrating (a) a through crack, (b) a partial crack and (c) an internal crack in a single ply.

For the preciseness of communication, the following terms are defined: (1) a “through crack” is defined as a crack that traverses the entire width of a specimen and therefore it is optically visible at both edges; (2) a “partial crack” is defined as a crack that intersects only one of the edges (only visible at one edge) and (3) an “internal crack” is defined as a crack that does not intersect either of the edges (an optical examination will completely miss this crack). A schematic illustration of a through crack, a partial

crack and an internal crack is shown in Figs. 1.3(a), (b) and (c), respectively. Using ultrasonic NDE, X-radiography, optical microscopy, and by cutting the specimens (destructive evaluation), Maslov et al. [10] have reported the existence of through cracks, partial cracks and internal cracks in three-ply [0/90/0] carbon-fibre/bismaleimide laminates. Consequently, techniques like optical microscopy (including edge replication), which rely solely on the visual examination of the laminate edges for crack detection, will miss the cracks that do not run to the edge under examination. Figure 1.4 illustrates this drawback of the optical microscopy technique in detecting matrix cracks in an eight-ply graphite/epoxy (IM7/5250) composite laminate with a [90/45/0/-45]_s stacking sequence. Edges 'A' and 'B' were examined under a high-power microscope at 200X magnification over a 30 mm length of the damaged laminate. Cracks in only the first ply (90° orientation) were recorded. The locations of these cracks at the edges are schematically represented by vertical lines drawn above edge 'A' and below edge 'B' respectively. Of the 18 intersections of the matrix cracks with the edge 'B' and six intersections with the edge 'A', only three correspond to through cracks (T); the remaining correspond to partial cracks (P). In situations such as this, optical microscopy will lead to a grossly incorrect determination of the matrix cracks.

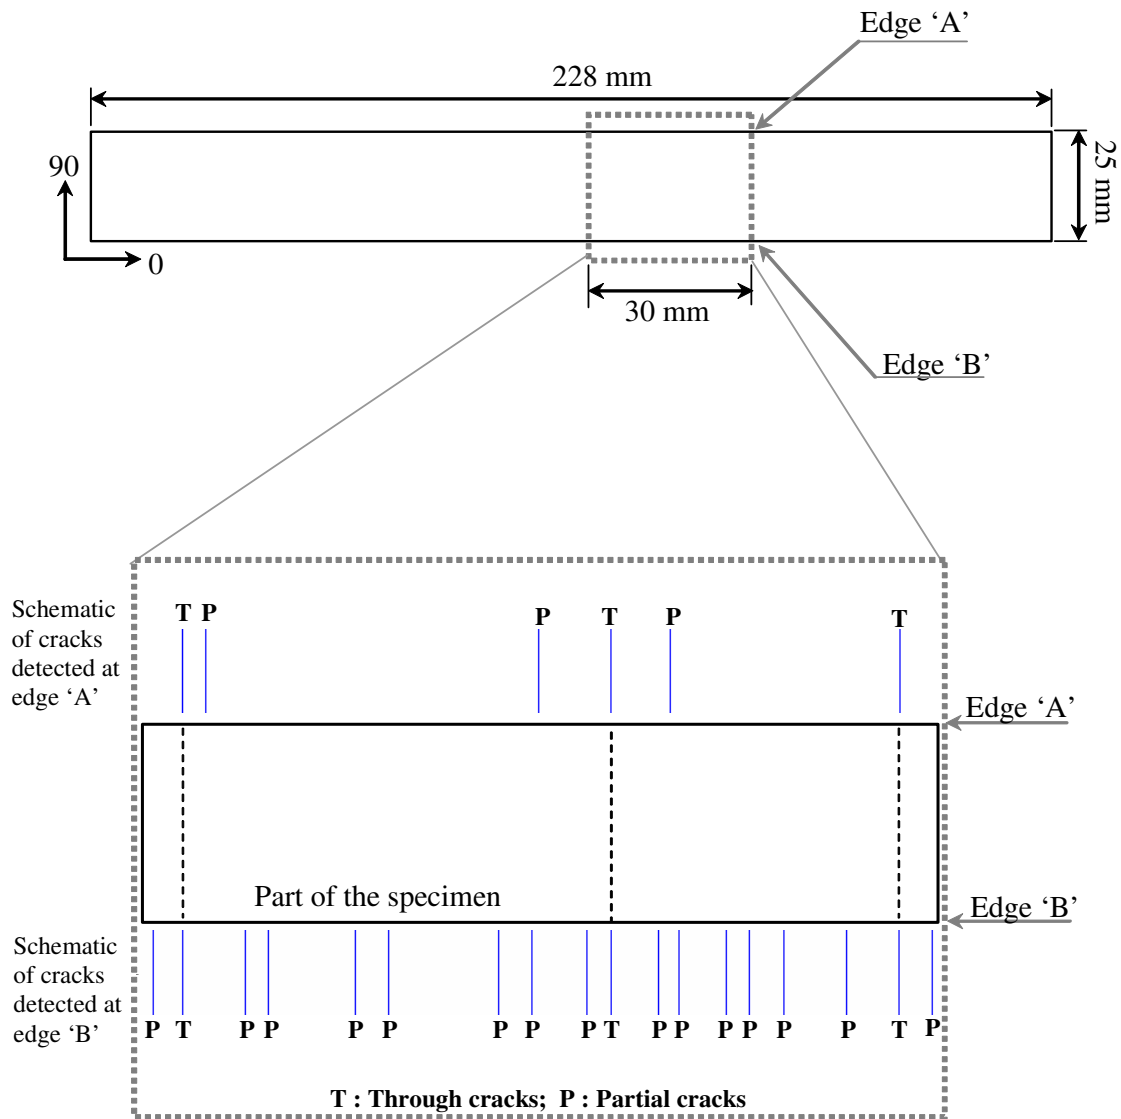
Fig. 1.4 A schematic showing the cracks in the first ply (90°) of a $[90/45/0/-45]_s$ graphite/epoxy laminate as detected by optical microscopy.

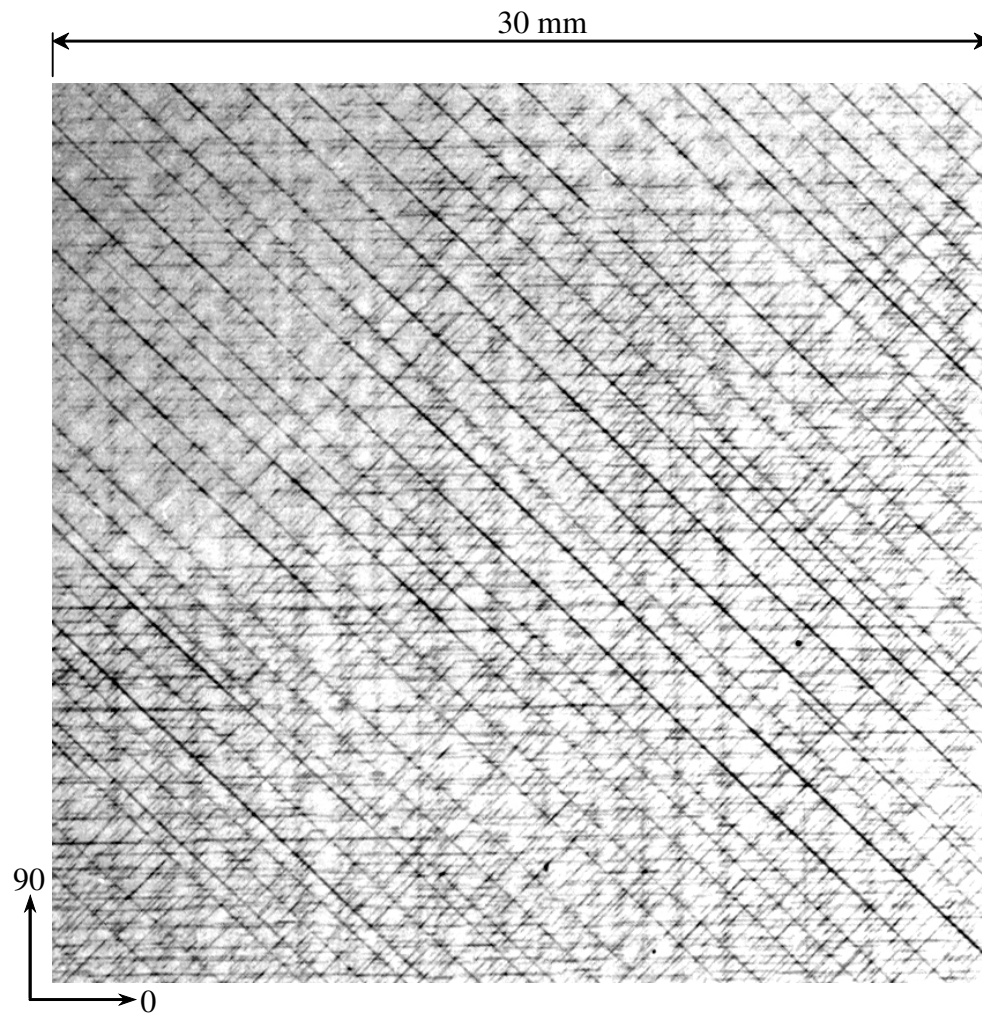
Fig. 1.5 X-ray image showing matrix cracks (dark lines) in a an eight-ply $[90/45/0/-45]_s$ graphite/epoxy laminate.

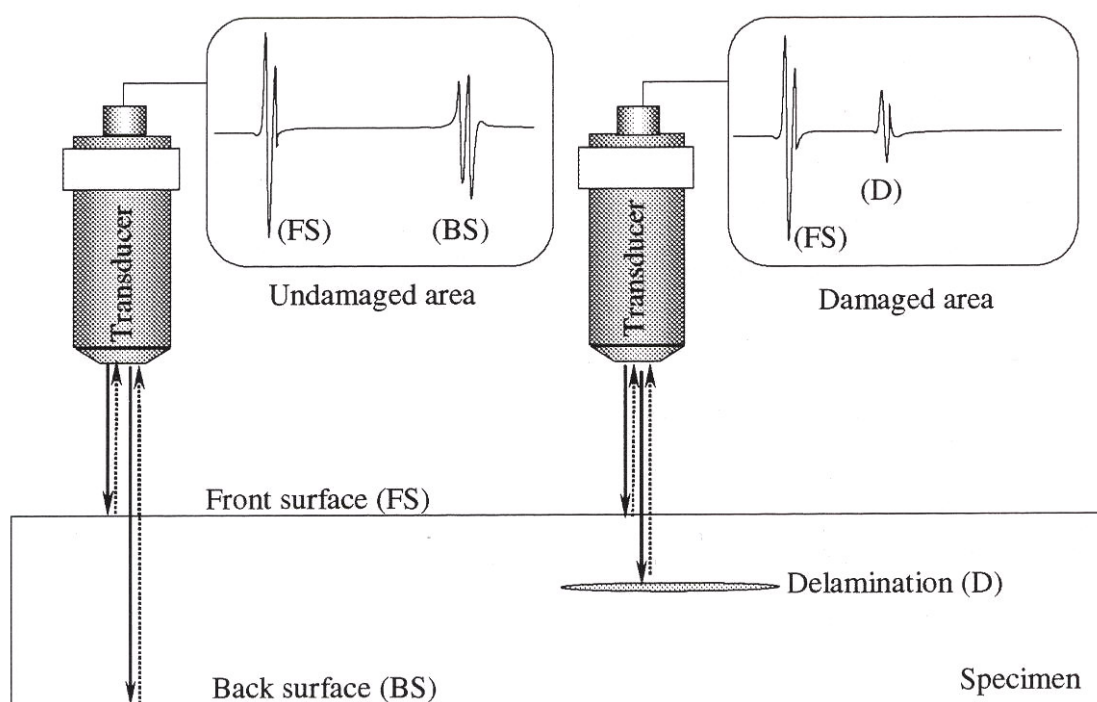
Fig. 1.6 A schematic of a typical ultrasonic nondestructive evaluation setup.

The basic concept behind ultrasonic nondestructive evaluation may be explained as follows. With the help of a transducer, ultrasonic waves are generated and made incident on the specimen under investigation. The waves then propagate through the material and respond to the presence of flaws, elastic properties and geometry of the specimen. A receiving transducer detects the waves emerging from the specimen which are then analyzed to characterize the defects and mechanical properties. Figure 1.6 shows the schematic of a typical experimental setup for the ultrasonic detection of a delamination as an example.

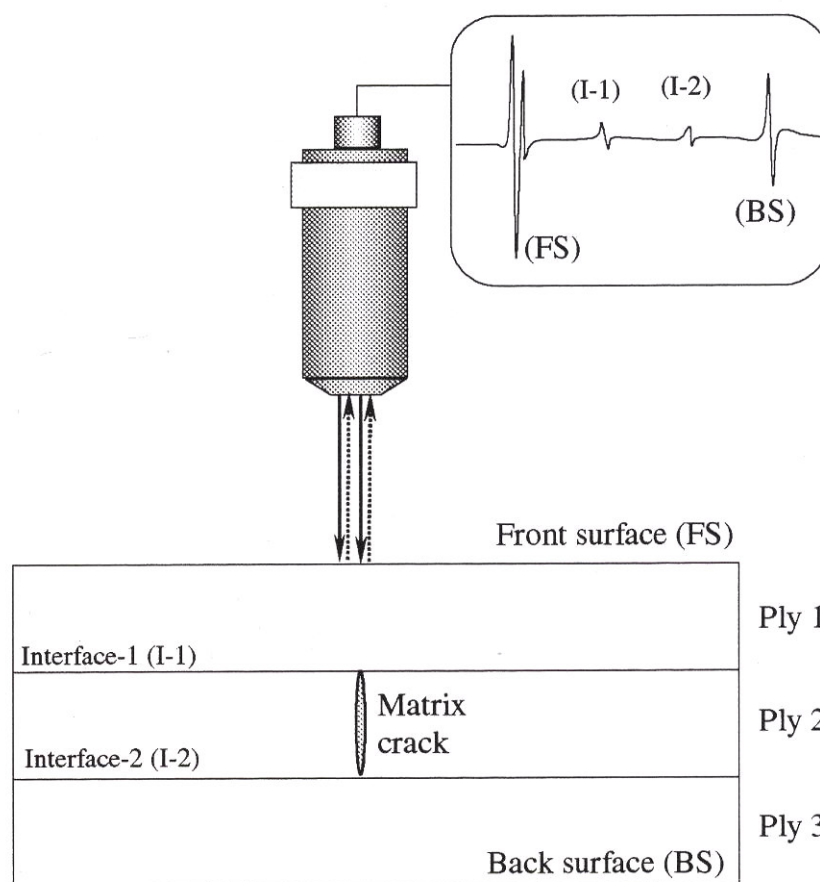
Fig. 1.7 A schematic of setup for the detection of matrix cracks in a laminated composite using the normal incidence ultrasonic technique.

This technique employs the scanning of a specimen with a normally incident ultrasonic transducer in the pulse-echo mode or the through-transmission mode. A focused or a flat transducer may be used. Traditionally, this technique has been used for the detection of defects which are in the plane of the laminate and perpendicular to the incident ultrasonic waves; for example, delaminations. Normal incidence is considered unsuitable for the detection of matrix cracks since the cracks are parallel to the incident waves; see Fig. 1.7. However, some researchers *have* used it for detection of matrix cracks in cross-ply laminates by way of measuring the attenuation of ultrasonic waves caused by the presence of the cracks; see, for example, Wooh and Daniel [14], Moran et al. [15] and Kaczmarek [16]. In Wooh and Daniel [14], results using normal incidence have been reported only for 40-ply thick $[0_{10}/90_{10}]_s$ laminates with cracks having crack-length 2.54 mm in the 90_{20} ply-group. Moran et al. [15] tested specimens with lay-ups $[90_4/0_4]_s$ with cracks in both the 90_4 ply-groups; however, the results reported using the normal incidence technique did not distinguish between the cracks in the two ply-groups. Kaczmarek [16] tested $[0_2/90_2]_s$ laminates with cracks in the 90_4 ply-group and $[90_2/0_2]_s$ with cracks in both the 90_2 ply-groups. In this work too, for the $[90_2/0_2]_s$ laminates, the results did not distinguish between the cracks in the two distinct 90_2 ply-groups.

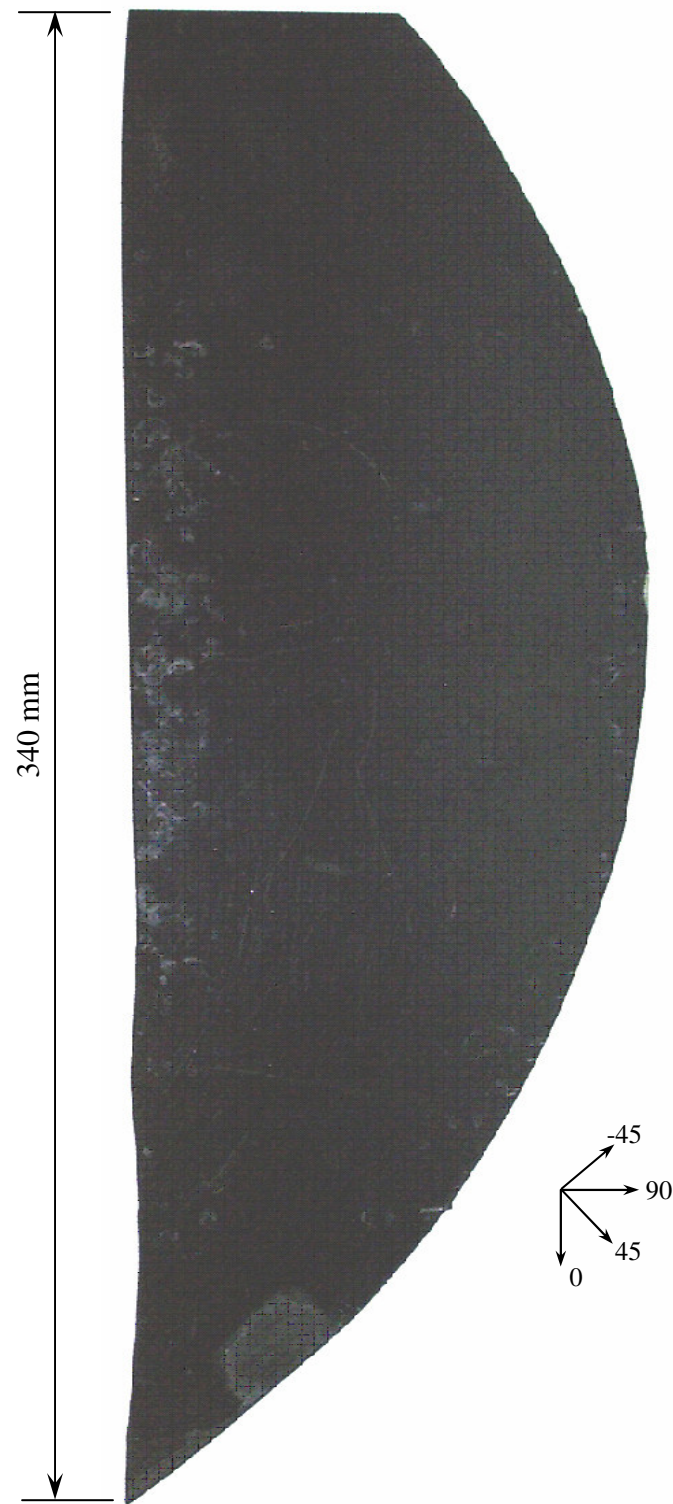
Fig. 2.1 A photograph of the eight-ply TAMU-1 specimen.

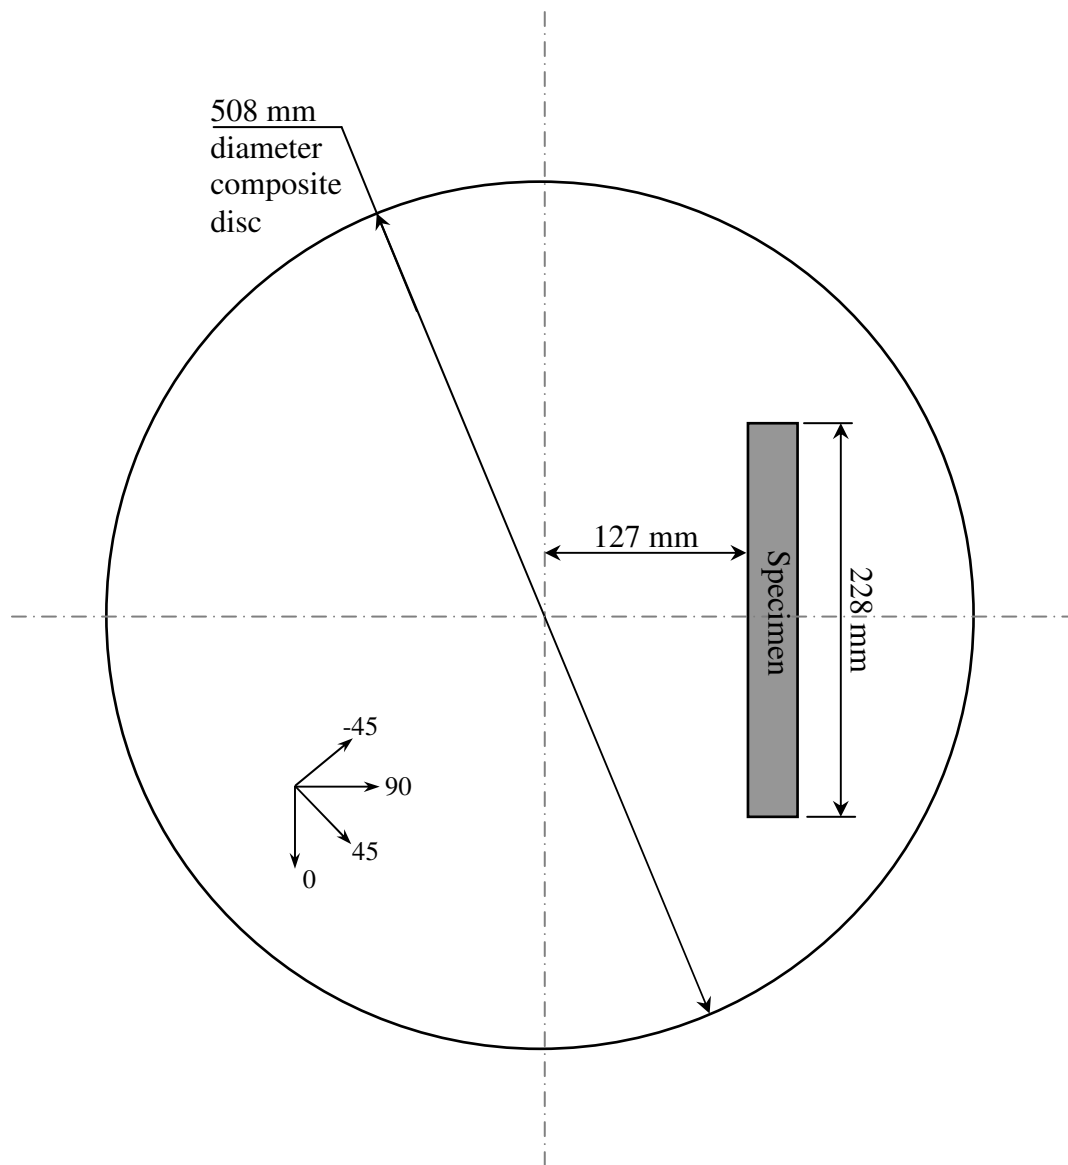
Fig. 2.2 A schematic showing the location of TAMU-2, TAMU-3 and TAMU-4 specimens on the corresponding composite discs.

TAMU-1 through TAMU-4 specimens were cut from four different 508 mm (20") diameter composite discs with a quasi-isotropic $[90/45/0/-45]_s$ lay-up. These specimens were obtained from NASA-MSFC. Each disc was subjected to LH_2 permeability test during which, damage was produced due to the application of cyclic thermo-mechanical loading. The test was stopped when the leakage through the discs exceeded a certain pre-specified limit. The specimens were cut from the discs after the test, for inspection. TAMU-1 was cut in an arbitrary shape that included the circumference of the corresponding disc from an unknown location; a photograph of the TAMU-1 specimen is shown in Fig. 2.1. TAMU-2, TAMU-3 and TAMU-4 were cut in the shape of 25 mm x 228 mm (1" x 9") rectangular panels from similar locations on the corresponding discs (Fig. 2.2). Photographs of the TAMU-2, TAMU-3 and TAMU-4

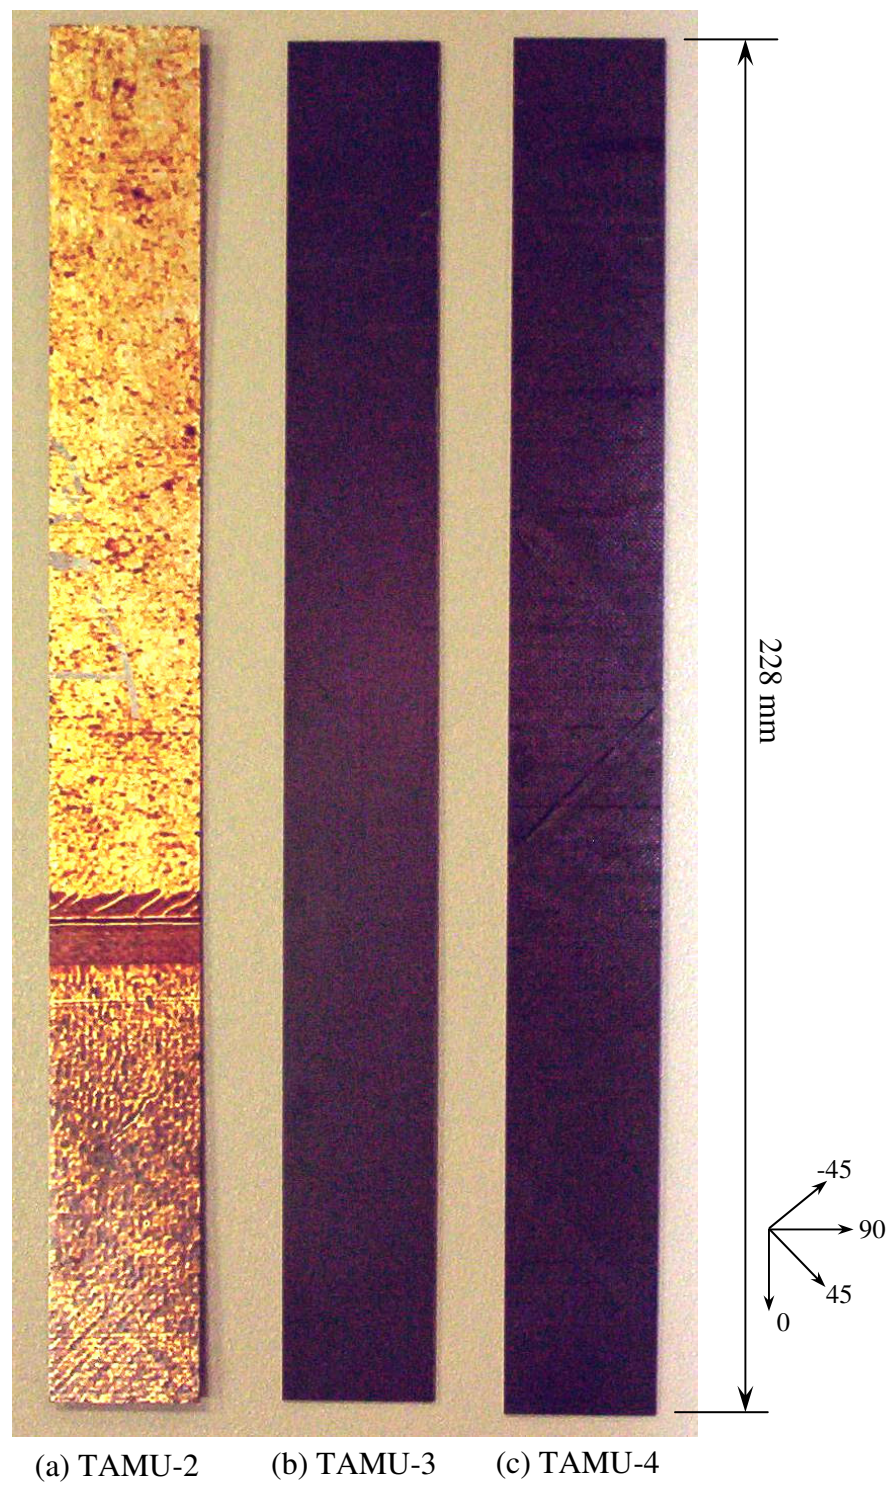
Fig. 2.3 Photographs of the TAMU-2, TAMU-3 and TAMU-4 specimens.

are shown in Fig. 2.3(a), Fig. 2.3(b) and Fig. 2.3(c) respectively. On one side of the TAMU-2 specimen, the surface was covered with a thin aluminum liner, whereas the other side of the specimen presented a rough ply-surface (characteristic of the scrim cloth used during manufacturing of the composite). The thickness of the liner was estimated to be approximately 20 μm . Optical micrograph of one of the edges of the specimen, showing the aluminum liner, at 200X magnification, is presented in Fig. 2.4. The TAMU-3 specimen showed similar physical characteristics except that on one surface it had a tedlar (polyvinyl fluoride) liner. Optical micrograph of an edge of the specimen showing the liner is presented in Fig. 2.5. The thickness of the liner was about 25 μm . TAMU-4 specimen did not have a liner, but both ply-surfaces were rough.

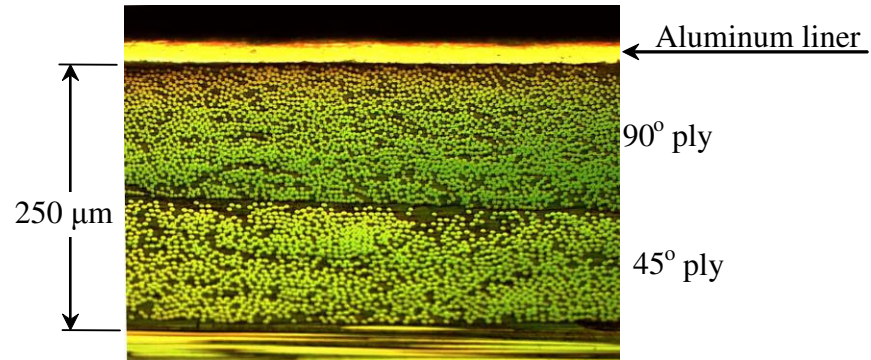
Figure 2.4 An optical micrograph of an edge of the TAMU-2 specimen showing the aluminum liner.

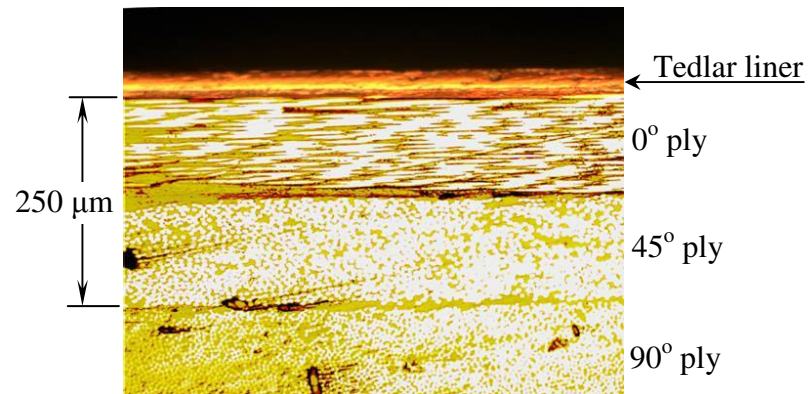
Figure 2.5 An optical micrograph of an edge of the TAMU-3 specimen showing the tedlar (polyvinyl fluoride) liner.

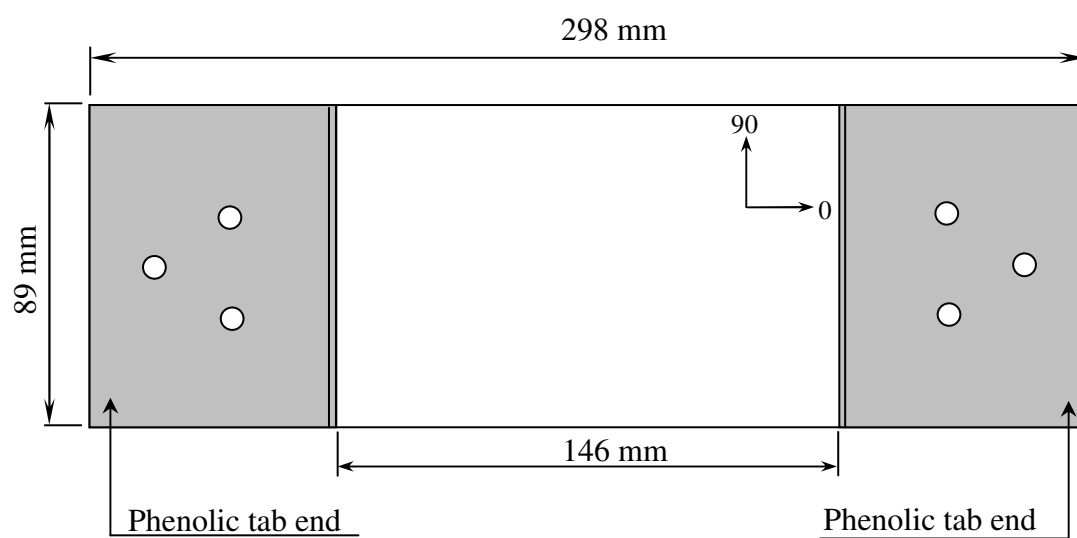
Fig. 2.6 A schematic of the 18-ply TAMU-5 specimen.

TAMU-5 is an 18-ply $[0/45/90/-45/0/45/90/-45/0]_s$ laminate in the form of a 89 mm x 298 mm (3.5" x 12") panel obtained from Lockheed Martin Michoud (LMM), New Orleans, Louisiana. This specimen was subjected to cyclic thermo-mechanical loading at cryogenic temperature during Helium (4.55 K) permeability tests at the LMM facility. A schematic of this specimen is shown in Fig. 2.6.

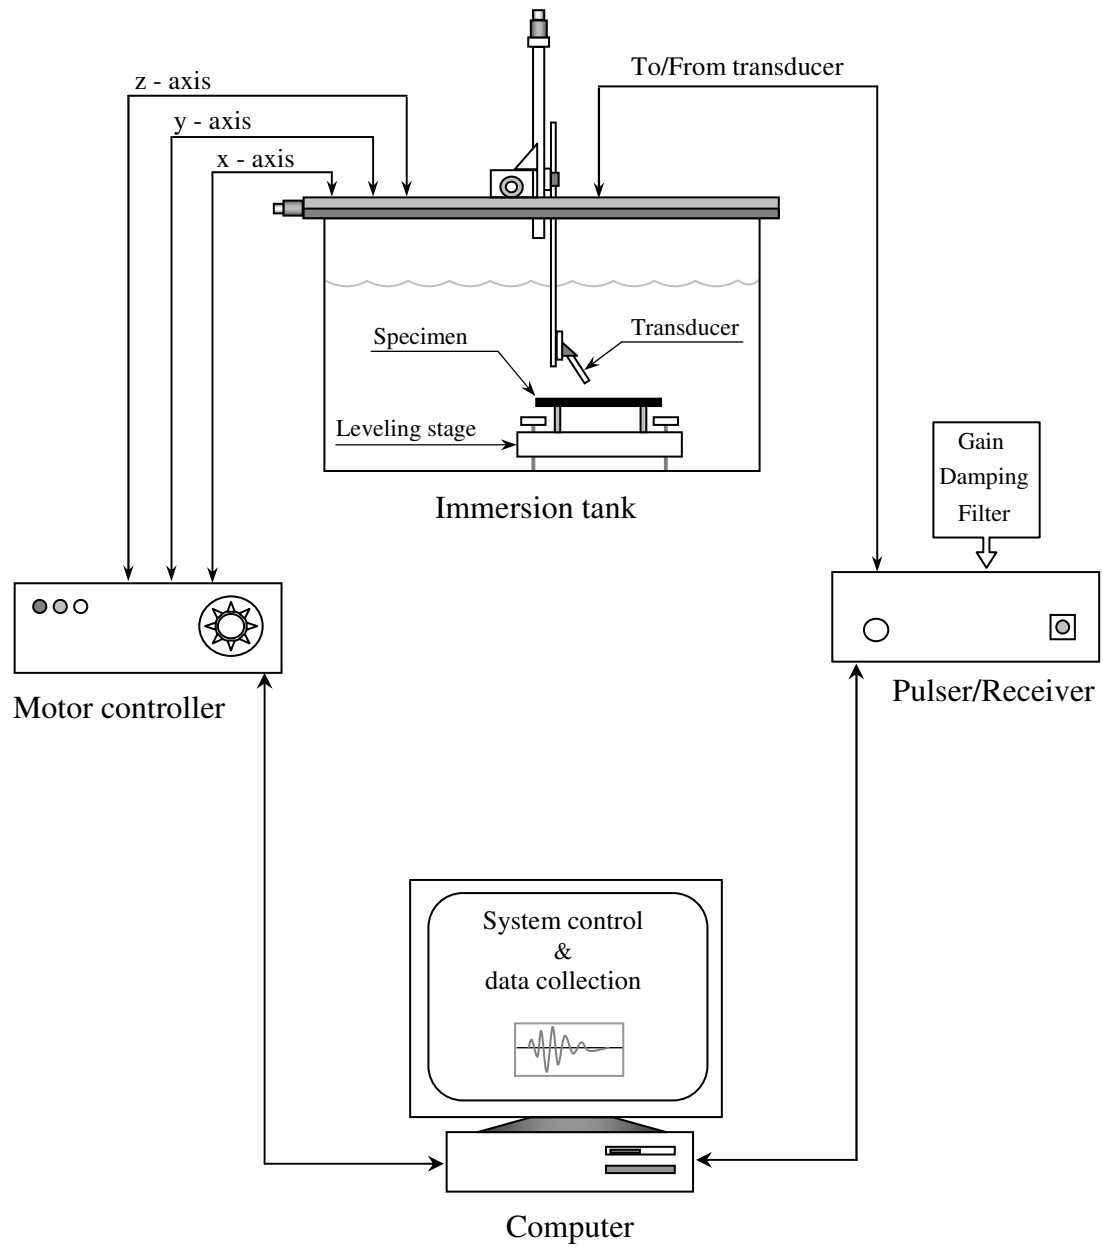
Fig. 2.7 A schematic representation of the ultrasonic scanning system.

All the ultrasonic data in this work were collected using a SONIX FlexSCAN ultrasonic scanning system (SONIX [25]). A schematic of the system is shown in Fig. 2.7. The setup consists of an immersion tank fitted with a scanning carriage platform. The motorized platform is computer-controlled and is capable of moving an ultrasonic

transducer along three mutually perpendicular axes in steps as small as 10 μm . The transducer is powered by a SONIX Pulser/Receiver (DPR35-S) system through which the input energy, gain, attenuation and high-pass filter can be controlled. The pulser/receiver allows the tests to be conducted in either the pulse-echo mode or the through-transmission mode. Water at room temperature was used as the couplant for all the tests.

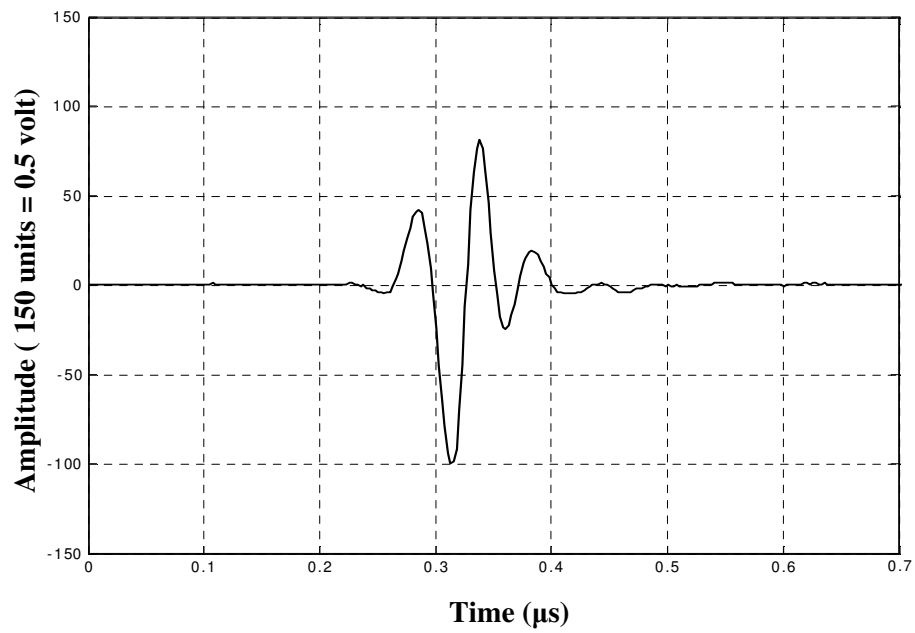
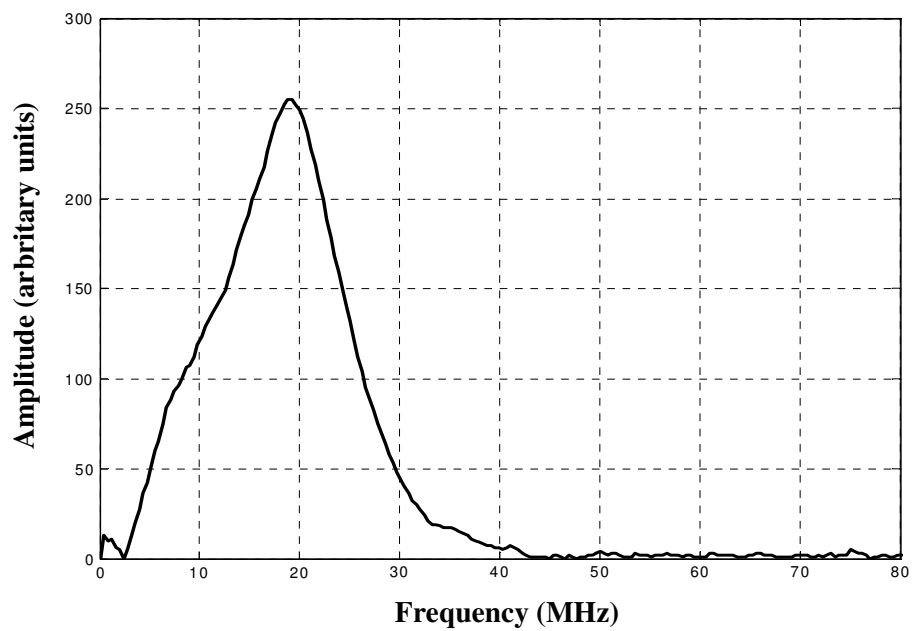
(a) Time domain

(b) Frequency domain

Fig. 2.8 Response of the 20 MHz transducer;
(a) time domain, (b) frequency domain.

Two broad-band, spherically focused transducers with center-frequencies of 20 MHz and 25 MHz were used in this work. The 20 MHz transducer had a 6.35 mm element diameter and 25.4 mm nominal focal length in water (Panametrics [26]), while the 25 MHz transducer had an 8 mm element diameter and 12.5 mm nominal focal length in water. Frequency response for the 20 MHz and 25 MHz transducers was obtained by making the transducers normally incident on a thick aluminum specimen with a highly polished surface and taking the Fast Fourier Transform (FFT) of front surface reflection. The front surface reflection as obtained by the 20 MHz and the 25 MHz transducers in the time domain is shown in Fig. 2.8(a) and Fig. 2.9(a) respectively, and the corresponding FFT for the two transducers is shown in Fig. 2.8(b) and Fig. 2.9(b) respectively.

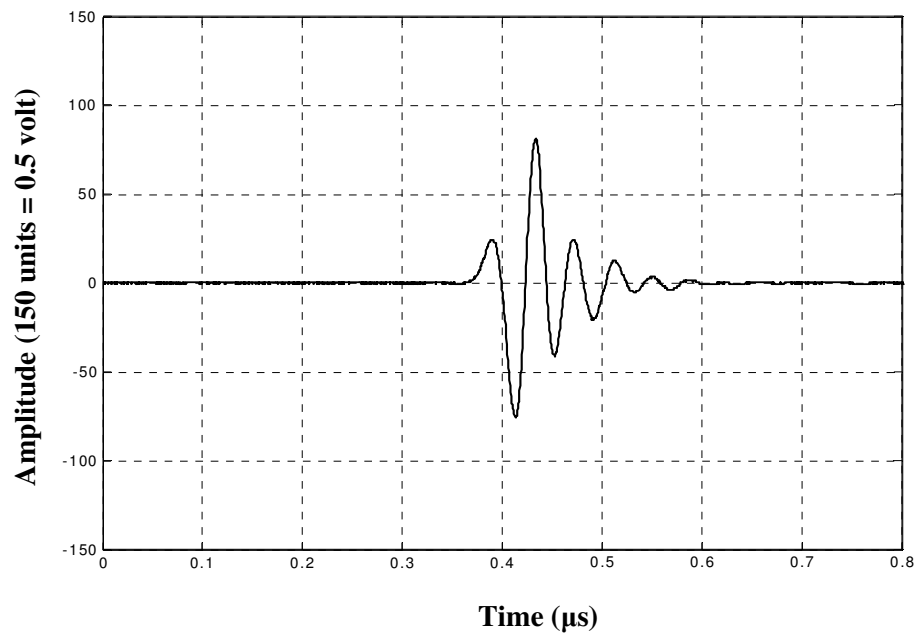
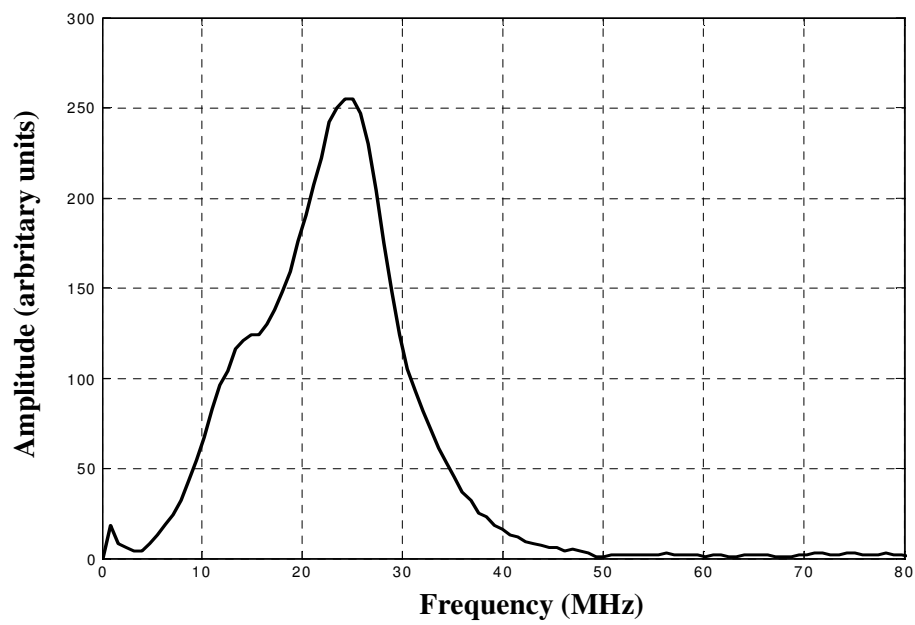
(a) Time domain

(b) Frequency domain

Fig. 2.9 Response of the 25 MHz transducer;
(a) time domain, (b) frequency domain.

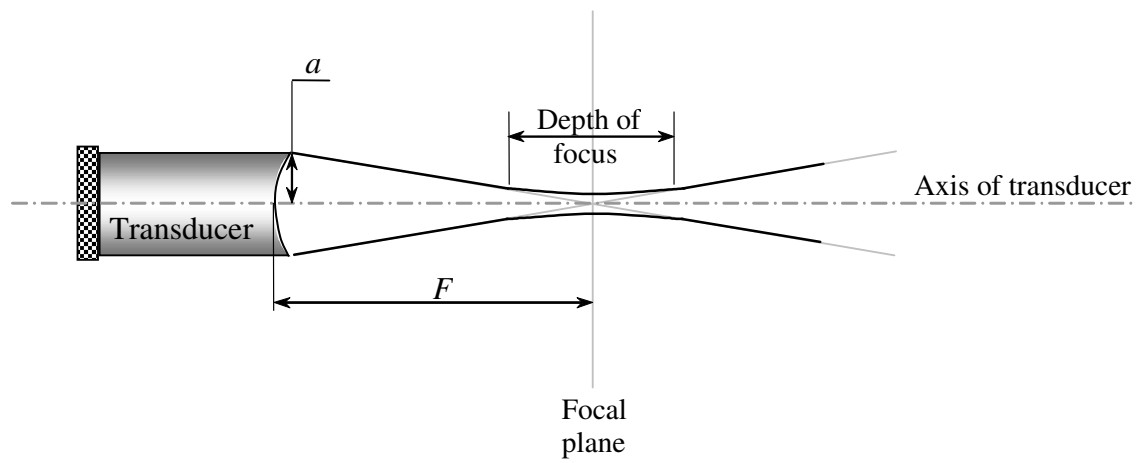
Fig. 2.10 Characteristics of the acoustic beam of a focused transducer.

A spherically focused transducer focuses the ultrasonic beam to a spot much smaller than the diameter of the transducer element, resulting in a much higher intensity of the acoustic beam near the region of the focal spot than at the transducer surface. A schematic illustrating the features of an acoustic beam from a focused ultrasonic transducer is shown in Fig. 2.10. To a first approximation, the acoustic beam converges

where λ is the wavelength of longitudinal waves in the coupling medium, F is the focal length of the transducer in the coupling medium and a is the radius of the transducer element. As an illustrative example, for a 20 MHz transducer with 3.18 mm element diameter and 25.4 mm nominal focal length the diameter of the focal spot in water ($\lambda_{\text{water}} = 0.075$ mm) is 0.31 mm. Diameter of the focal spot directly affects the sensitivity and the spatial resolution of a transducer. For a given size of a flaw (less than the diameter of the focal spot) positioned at the focal spot, as the diameter of the focal spot decreases, the fraction of the energy reflected by the flaw increases leading to increased sensitivity. In the case of multiple flaws, for proper spatial resolution (the ability to discern between two distinct flaws), the diameter of the focal spot should be less than or equal to the spacing between the flaws.

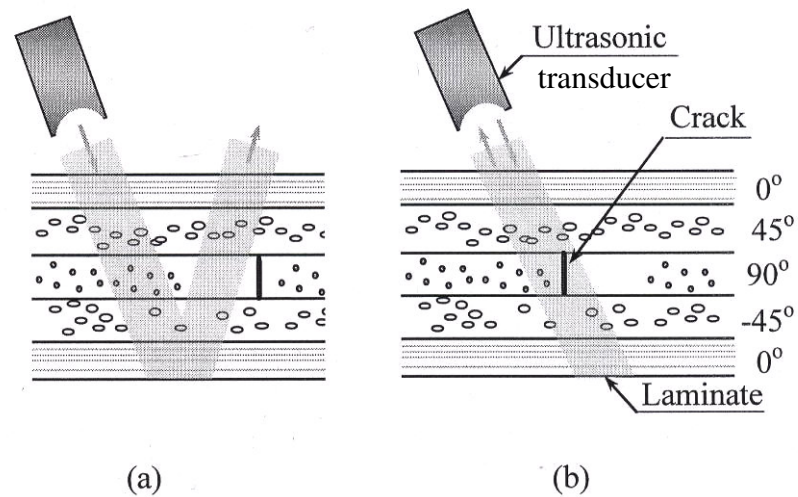
Fig. 2.11 A schematic of the concept underlying the ultrasonic polar backscattering technique. (All the incident and reflected waves are collectively represented by arrows pointing into and out of the specimen respectively. The shaded area is a symbolic representation of the complicated interaction between the incident beam, the crack and the ply boundaries.)

The polar backscattering technique uses an obliquely incident ultrasonic beam as opposed to the conventional ultrasonic pulse-echo technique, which uses normally incident ultrasonic beam. The basic concept underlying the backscattering technique may be explained as follows. In the absence of a matrix crack the incident signal is reflected away from the transducer, which is configured to act as a transmitter as well as a receiver. This is illustrated in Fig. 2.11(a). For ease of understanding, the incident and reflected fields are collectively represented by arrows as shown in Figs. 2.11(a) and 2.11(b). The shaded area is a symbolic representation of the complicated interaction between the incident beam, the crack and the ply boundaries. When the crack is insonified by the incident beam, the incident signal interacts with the crack and is partly reflected back towards the transducer, as illustrated in Fig. 2.11(b).

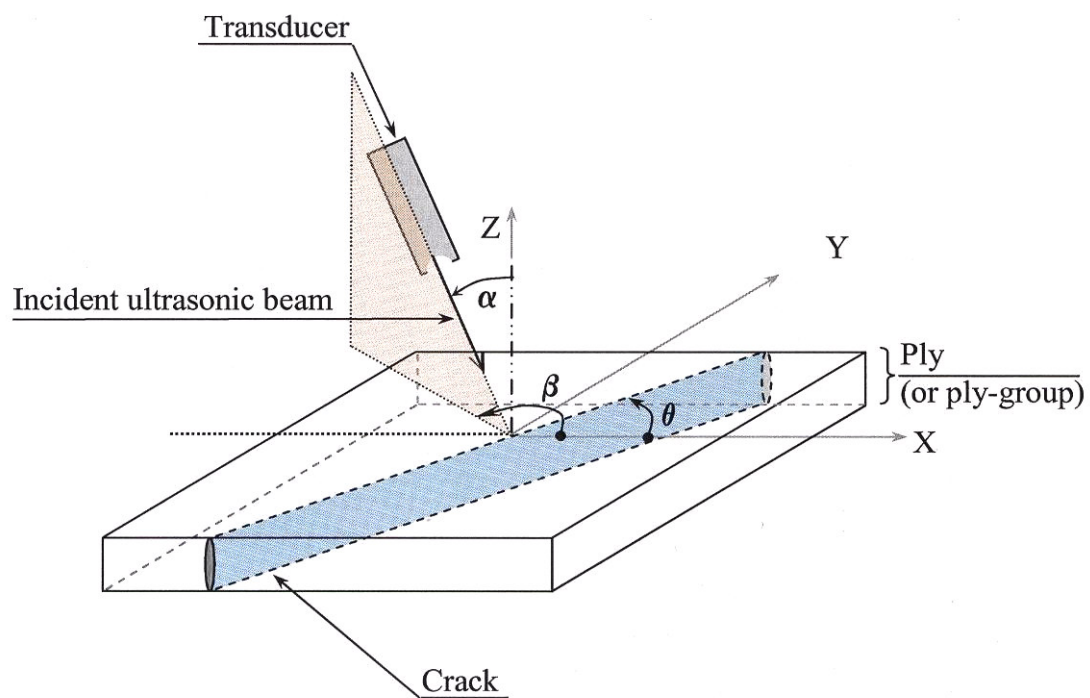
Fig. 2.12 A schematic showing a general spatial arrangement of the ultrasonic transducer with respect to a cracked ply or ply-group.

A schematic showing the spatial arrangement of a transducer with respect to the orientation of a crack in a ply or a ply-group (i.e., adjacent plies of the same orientation) is shown in Fig. 2.12. An orthogonal coordinate system is chosen such that XYZ axes define the laminate (global) coordinate system. The fibers in the ply (and therefore the cracks) are oriented at an angle θ from the X-axis. For the incident beam, let α be the

angle of incidence as measured from the normal and let β be the azimuthal angle measured from the X-axis, positive in the counter-clockwise direction. To determine the angle β at which the received signal is maximum, a small area of a specimen containing cracks was initially scanned using a transducer adjusted such that the projection of incident ray onto the laminate is perpendicular to the crack faces (i.e. $\beta = \theta \pm \pi/2$). Then, from this position, for a fixed angle of incidence and fixed height above the specimen, the transducer was rotated such that value β varied a few degrees back and forth from the initial adjustment. At each value of angle β , the same area was scanned again and the amplitude of the received signal from a particular crack was plotted. One such plot for a crack in the third ply ($\theta = 90^\circ$) of the 18-ply TAMU-5 specimen is shown in Fig. 2.13. A schematic of the plan view of the experimental arrangement is shown above the plot. The azimuthal angle β was initially set at 180° and varied over a range of $24^\circ (\pm 12^\circ)$ from the initial value, in steps of 2° . The relative amplitude on the y-axis is in decibels and is calculated as
